Inspection Report
Minerals Regulatory Program
Report Date: February 28, 2005

Mine Name: Black Ridge #1
Operator or Permittee Name:
Thirstystone Resources, Inc.
Permittee Mailing Address:
860 East 19th Street
Tuscon, Arizona 85719-6615

Permit number: S/053/027
Inspection Date: February 1, 2005

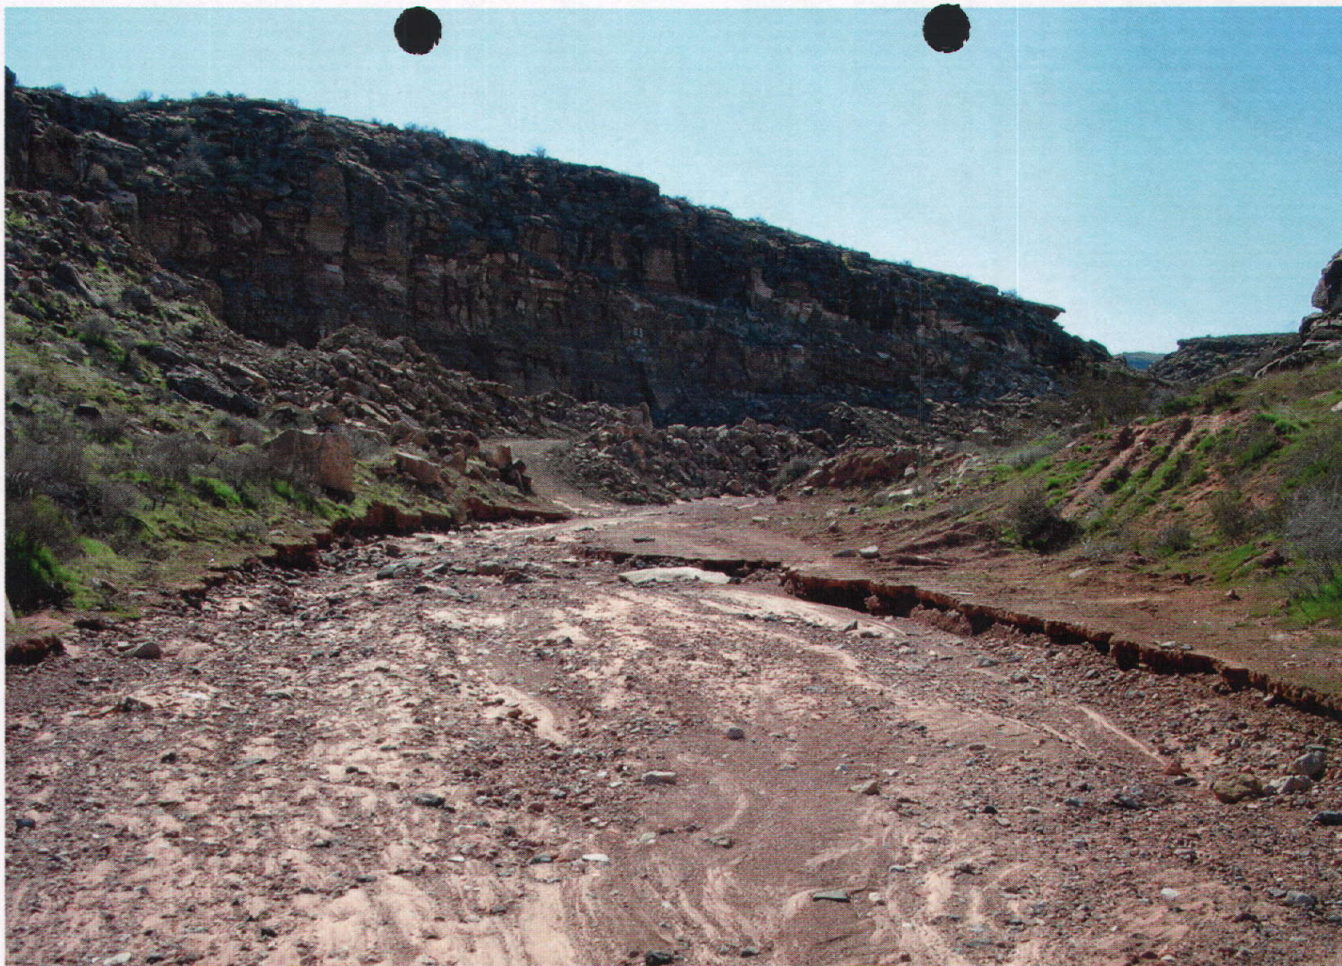
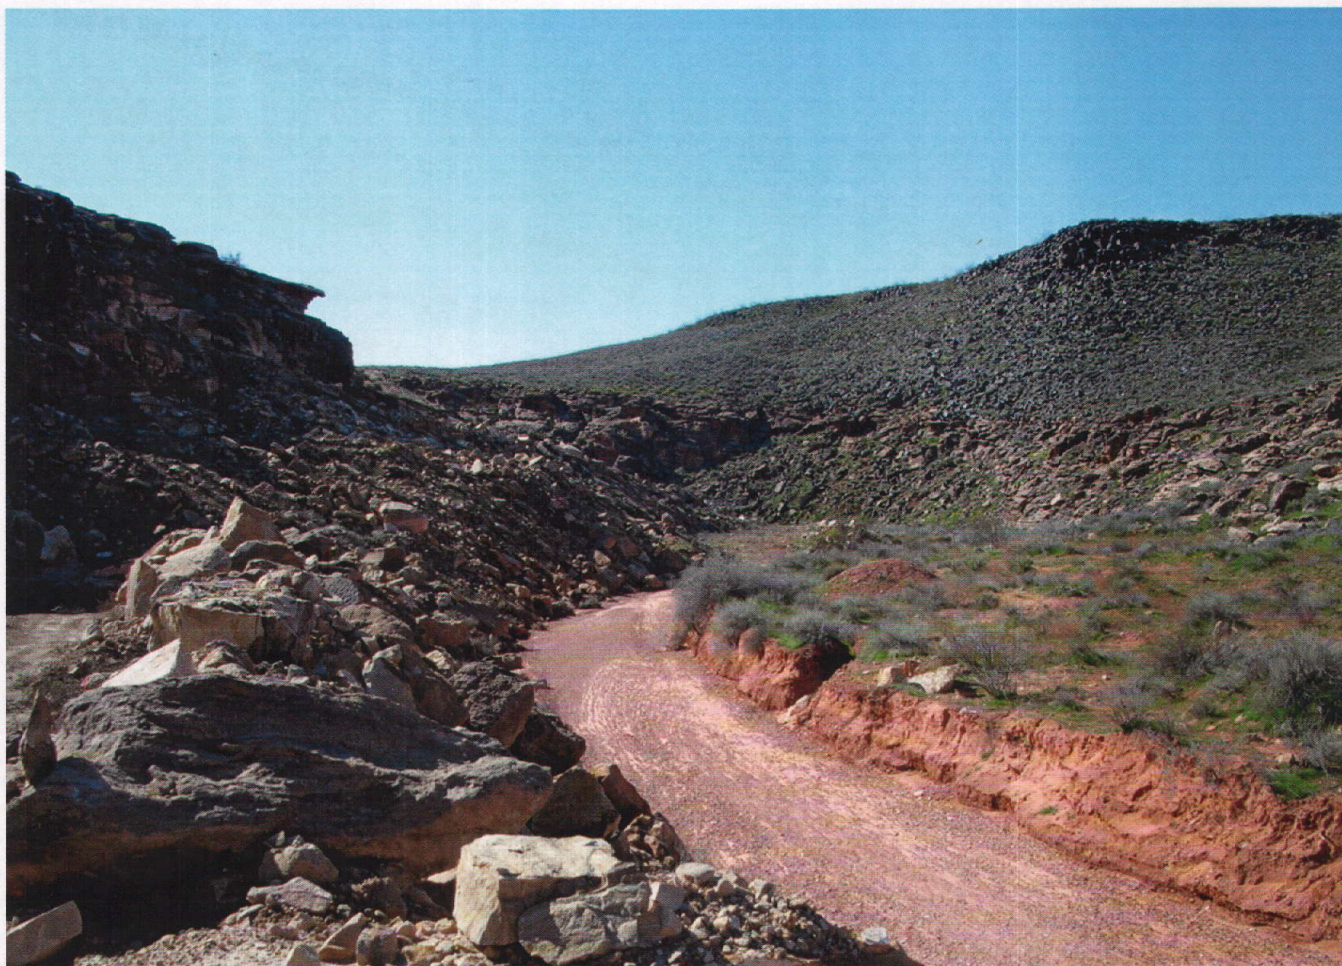
The site remains stable and it appears that the recent heavy rains in the area have not caused any major problems. The location of the waste dumps appears to be sufficiently out of the drainage that flooding has not caused any problems.

6. Roads (maintenance, surfacing, dust control, safety) The access road into the site is located in a drainage, I wanted to check access into the site. There has been some impacts due to the flooding there has not been any gullying due to recent storms. A portion of the access road was located on the sandy drainage bottom and although the drainage shows that some high water had passed through the site, It appears that access can still be made by the same route.
